**REPORT OF KPMG INC., IN ITS CAPACITY AS THE
COURT APPOINTED LIQUIDATOR OF SHEPHERD'S
VILLAGE MINISTRIES LTD. AND IN ITS CAPACITY AS
THE COURT APPOINTED INVESTIGATOR OF
CONDOMINIUM PLAN NO. 0020672**

DATED JANUARY 4, 2021.

Shepherds Village Condominium Corporation 092 5762

54 Avenue and 45 Street Valleyview, Alberta

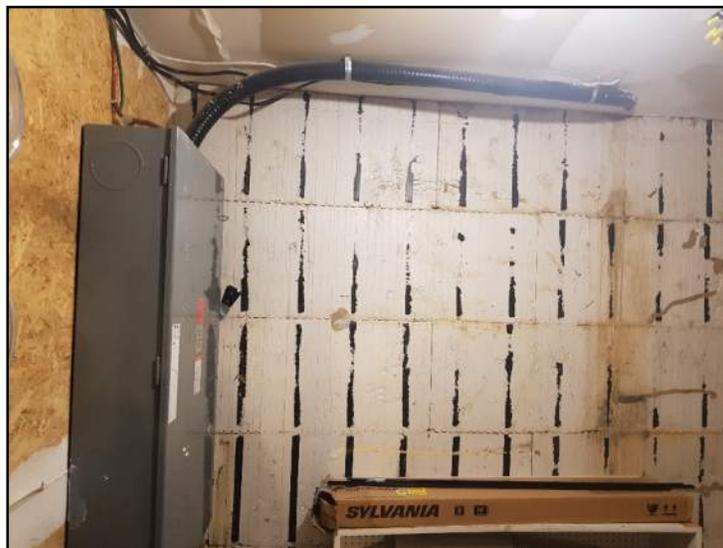
Water penetration at the beam pockets within the foundation walls was observed throughout the units (townhouses and the eight-plex units). It was also reported by the site manager that water is entering the mechanical room through an electrical conduit coming from a transformer at the south east side of the eight-plex and travelling to the floor drain in the mechanical room or towards the sump pump near the south most wall.

Photo 4.1.1.1-1 Water penetration at electrical conduit

Generally, the foundations are expected to last the life of the buildings. Further assessments are required to determine the cause and repair strategy of the water penetration. This is further discussed in the Superstructure section.

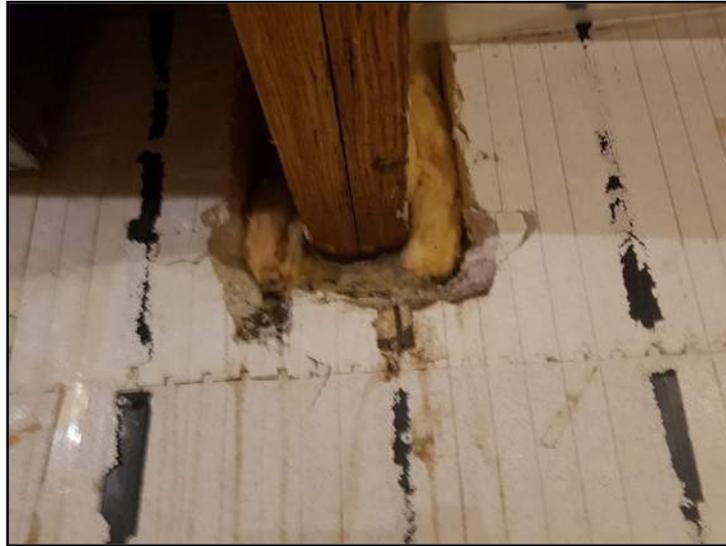
Photo 4.1.1.1-2 Typical beam pocket condition

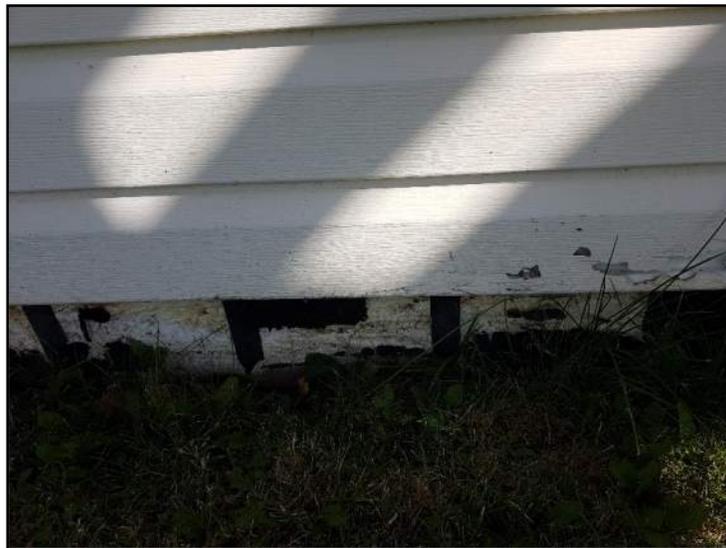
The foundation walls are generally at the same level as grade. Areas where the foundation walls are higher than the grade (typically only four inches) have exposed waterproofing membrane.

Photo 4.1.1.1-3 Typical exposed waterproofing on IFC foundation

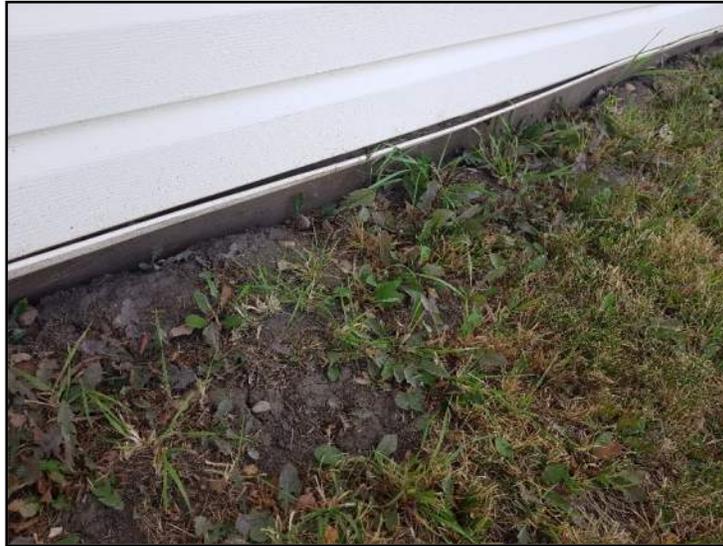
Photo 4.1.1.1-4 Typical level of grade to foundation wall

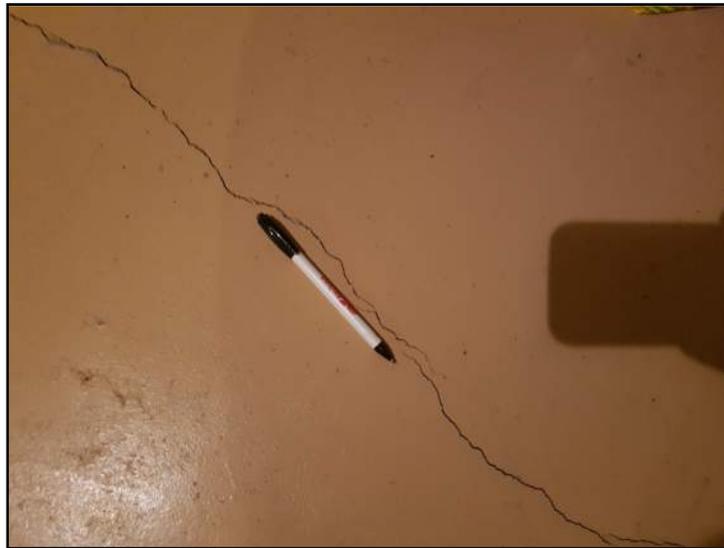
At the lowest level in each building, in the garages and the maintenance shop, the floor consists of a concrete slab-on-grade. At units accessed, we noted isolated cracking likely due to settlement; however, no heaving of the slabs was observed.

Photo 4.1.1.2-1 Typical crack on slab-on-grade

The slab-on-grade is expected to last the life of the building. Filling the gap between the slab-on-grade and the foundation walls with a flexible type material is recommended. This repair is expected to be at a cost below the report threshold and is therefore not included in the reserve fund.

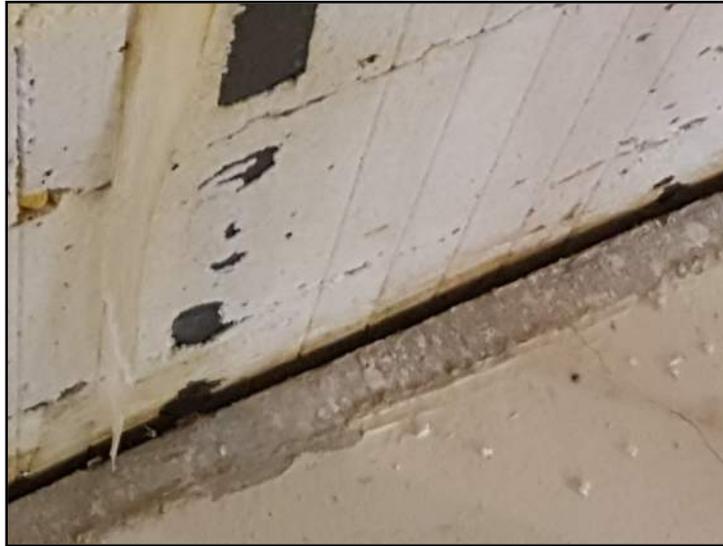
It was reported by the site manager that there is snow and ice buildup on the floor of the maintenance shop through the winter and during the spring thaw. MH observed a gap between the foundation wall and the floor, varying in size, at the east wall of the complex.

Photo 4.1.1.2-2 Gap between foundation wall and slab-on-grade

Assessments are required to determine the cause and repair strategy of the water penetration. This is further discussed in the Superstructure section.

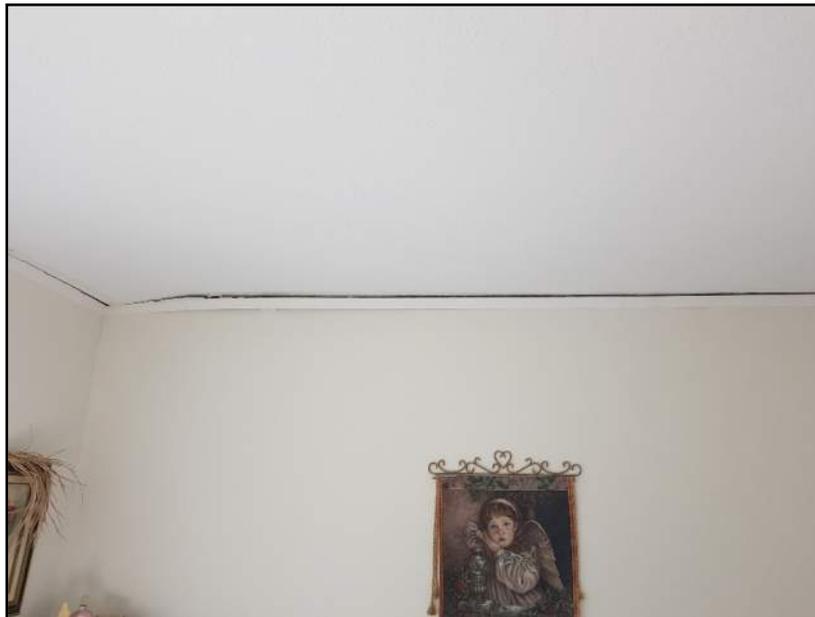
It was reported by the site manager that the top of the wall between the bedrooms in units 3 and 5 has shifted down and now there is a gap between the wall and the ceiling. MH observed from the exterior of the units the soffit appears to be angled in towards the building. MH also observed that the gypsum wall board is cracking in many units typically at the tops of door frames and at ceiling joints.

Photo 4.1.2.1-1 Ceiling gap between unit 3 and 5

Generally, the interior protected structural components are expected to last the life of the building. However, based on the observed water penetration at the foundations, cracks in the slab-on-grade, the shifting of the wall at units 3 and 5 and the cracks in the gypsum walls boards, further investigation is recommended. Therefore, funds have been allocated to complete a structural/drainage assessment for the complex.

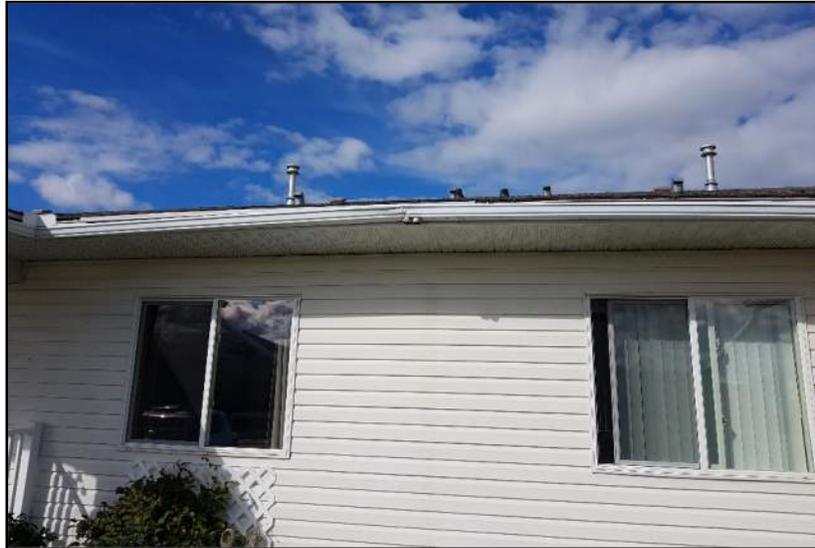
Photo 4.1.2.1-2 Shifted soffit

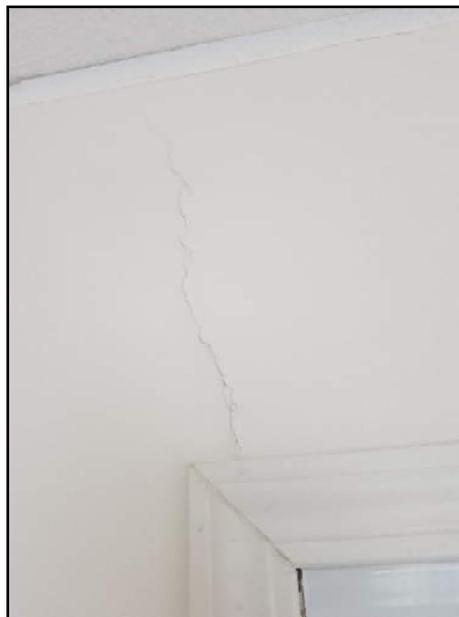
Photo 4.1.2.1-3 Crack in gypsum at door head

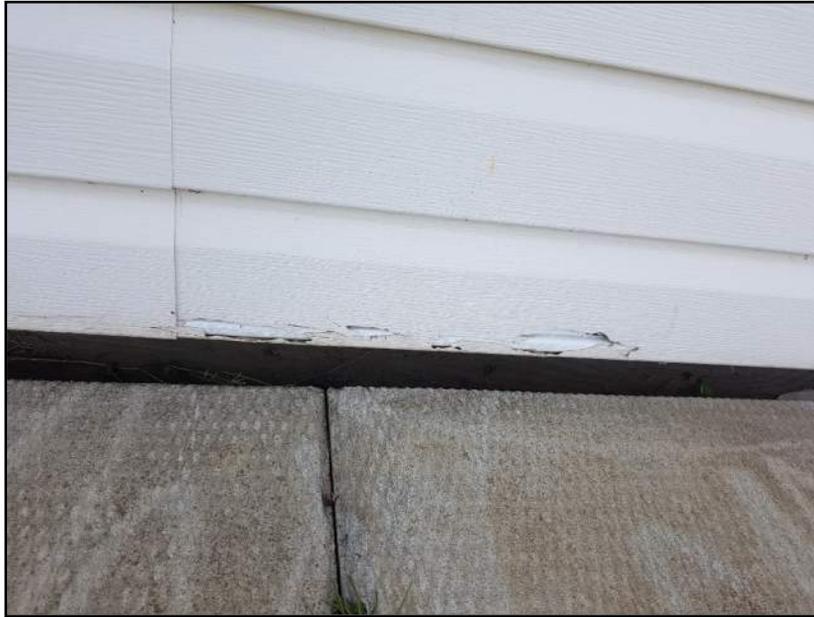
Generally, the vinyl siding is in fair condition as the bottom of the vinyl siding is damaged likely due to impact damage.

Photo 4.2.1.1-2 Typical damaged vinyl siding

Funds have been allocated to repair the vinyl siding over time (to address local issues such as impact damage).

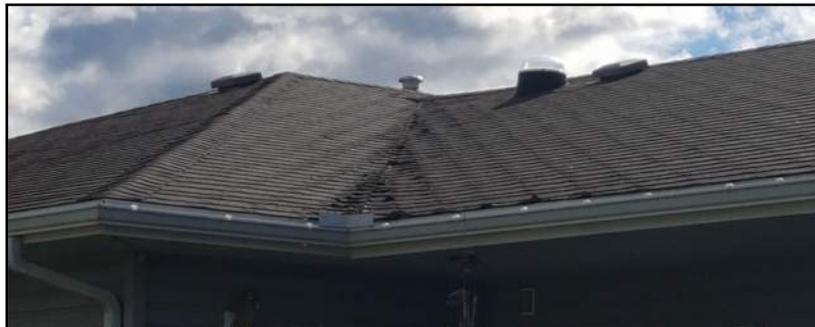
Photo 4.2.3.1-1 Typical 2000 / 2004 roof valleys

| Item No. | Recommendations | Fiscal Year of Expenditure | Expenditure Budget (in current fiscal year dollars) |
|---|--|---|---|
| 4.2.3.1a | Replace asphalt shingle roofs built in 2000-2004 | 2021 | \$273,000 |

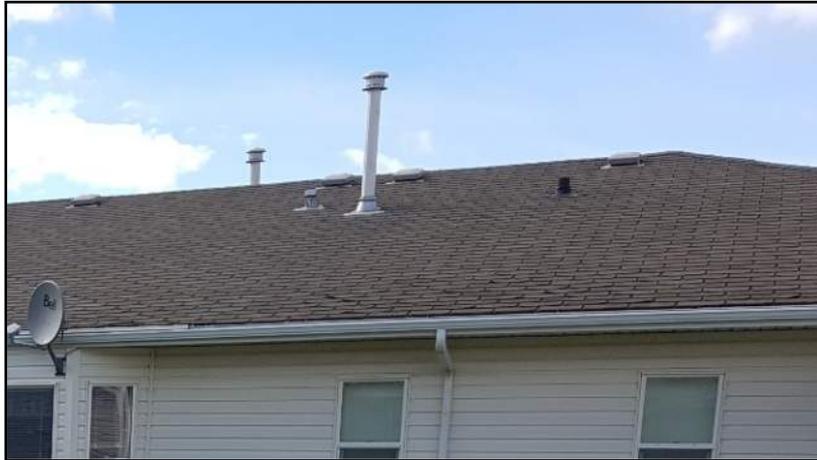
Photo 4.2.3.1-2 Typical 2006 / 2009 roof

| Item No. | Recommendations | Fiscal Year of Expenditure | Expenditure Budget (in current fiscal year dollars) |
|---|--|---|---|
| 4.2.3.1b | Replace asphalt shingle roofs built in 2006-2009 | 2026 | \$245,000 |

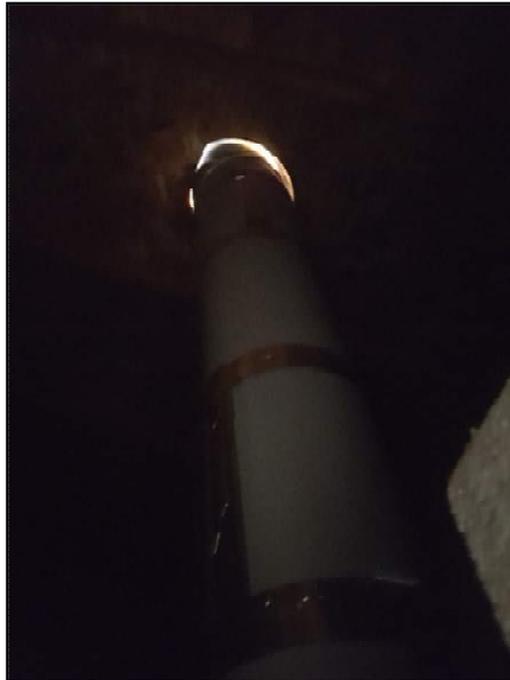
Photo 4.2.3.1-3 Unsealed vent stack

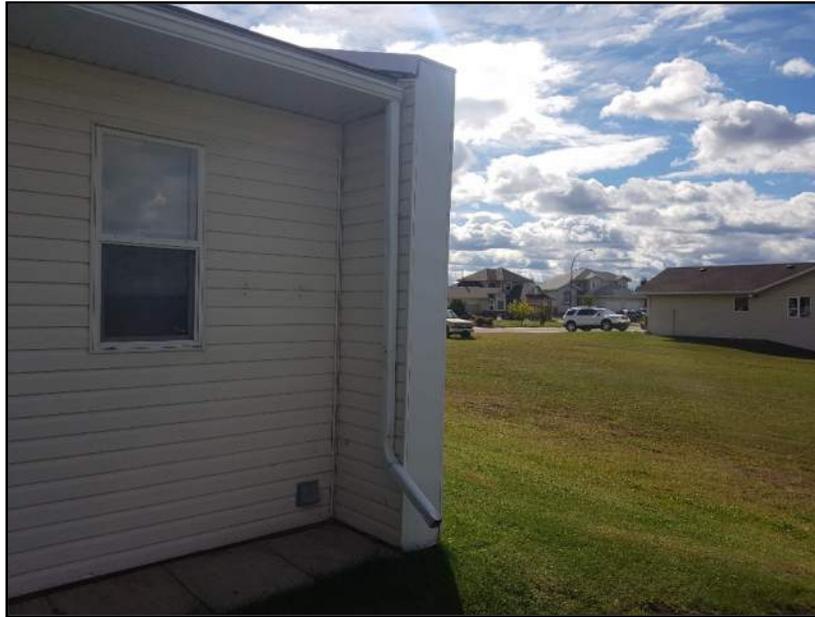
Photo 4.2.3.2-1 Typical eavestroughs and downspout

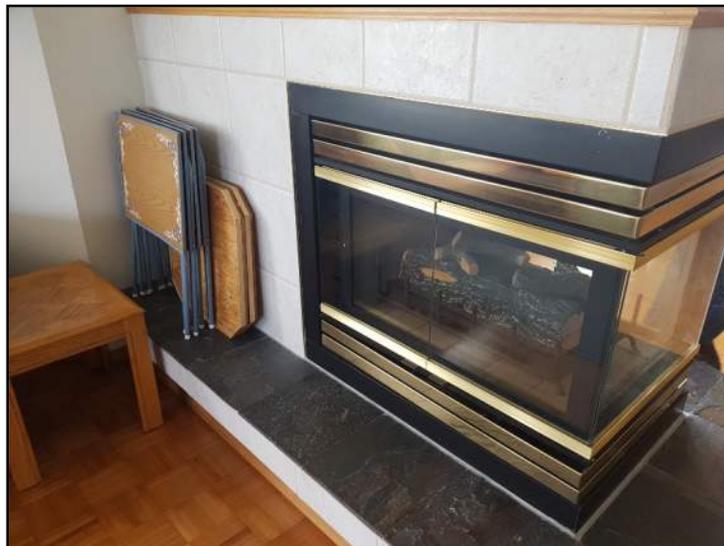
Photo 4.3.2.1-1 Fireplace

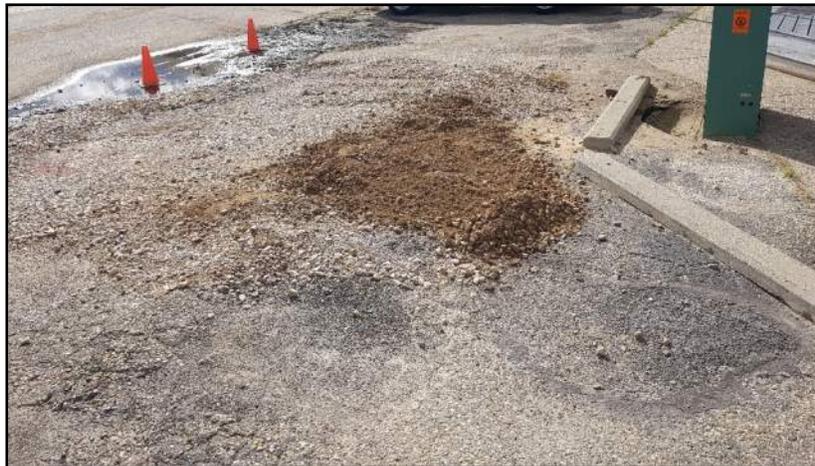
Photo 4.7.1.1-1 Typical paving condition

| Item No. | Recommendations | Fiscal Year of Expenditure | Expenditure Budget (in current fiscal year dollars) |
|---|--|---|---|
| 4.7.1.1 | Replace asphalt parking lot | 2022 | \$8,000 |

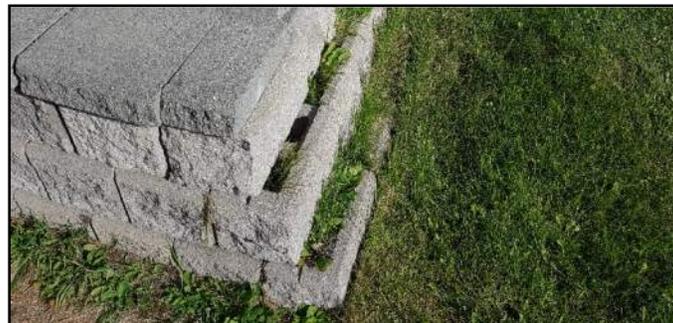
Photo 4.7.4.1-2 Shifted stacked stone retaining wall

| Item No. | Recommendations | Fiscal Year of Expenditure | Expenditure Budget (in current fiscal year dollars) |
|---|--|---|---|
| 4.7.4.1 | Repair retaining wall | 2025 | \$5,000 |
